APOLLO 11 MISSION REPORT

MANNED SPACECRAFT CENTER
HOUSTON, TEXAS
NOVEMBER 1969

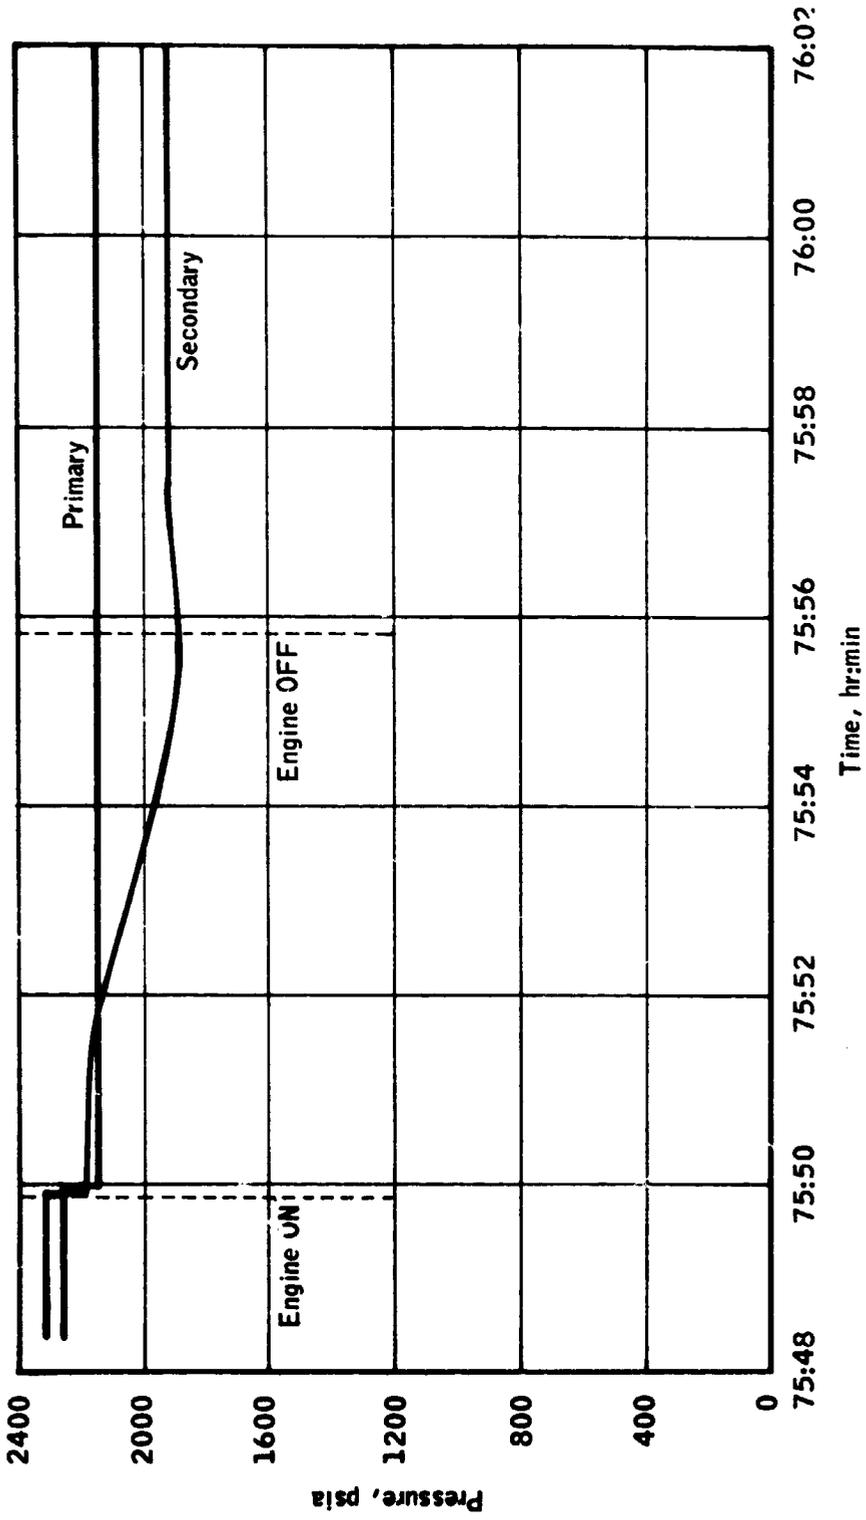
Figure 16-1.- Nitrogen pressure during initial lunar orbit insertion firing.

An abnormal decay in the secondary (system B) nitrogen pressure was observed during the lunar orbit insertion service propulsion firing, indicating a leak in the system which operates the engine upper bipropellant valve bank. No further leakage was indicated during the remainder of the mission. This anomaly is discussed in greater detail in section 16.1.1.
